REC-ERC-84-22

EVALUATION AND ANALYSIS OF MOTOR STARTING PROBLEMS AT FOUNTAIN VALLEY PUMPING PLANT

March 1984

Engineering and Research Center

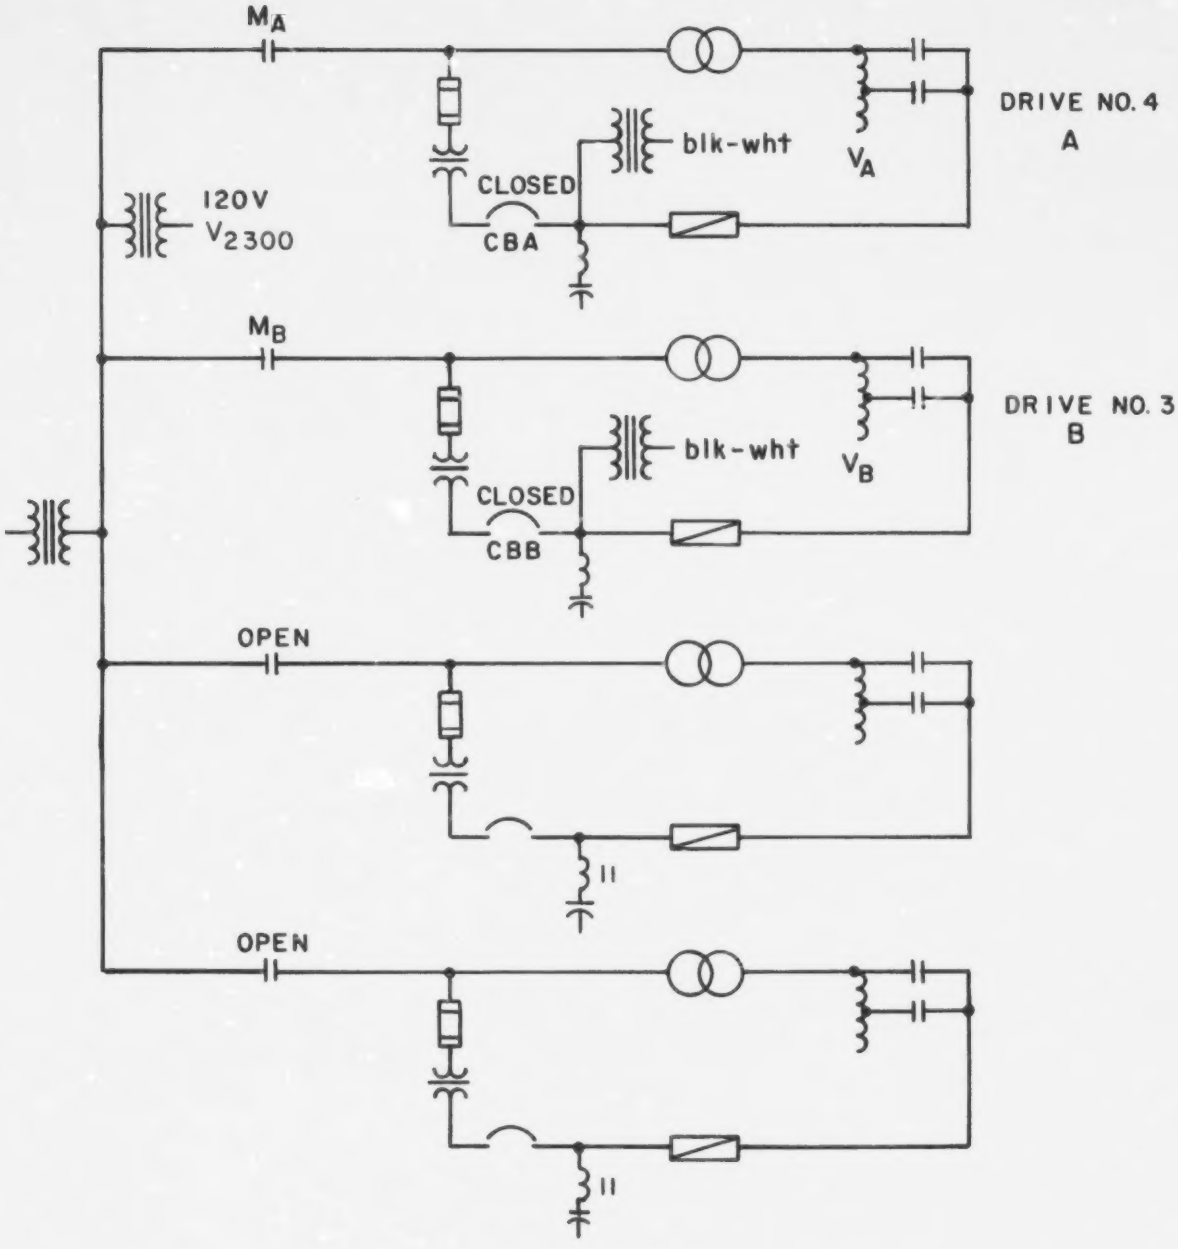
Figure C-1. – Test No. 1 system configuration.

NOTES: 1. GATES OFF AT ALL TIMES (DISCONNECTED S/S (No.12 SLB-1)
2. SEPARATE PT 2300:120 FOR V_{2300}
3. TEST NO. 1a CLOSE M_A
4. TEST NO. 1b CLOSE M_B WHILE M_A ALREADY CLOSED

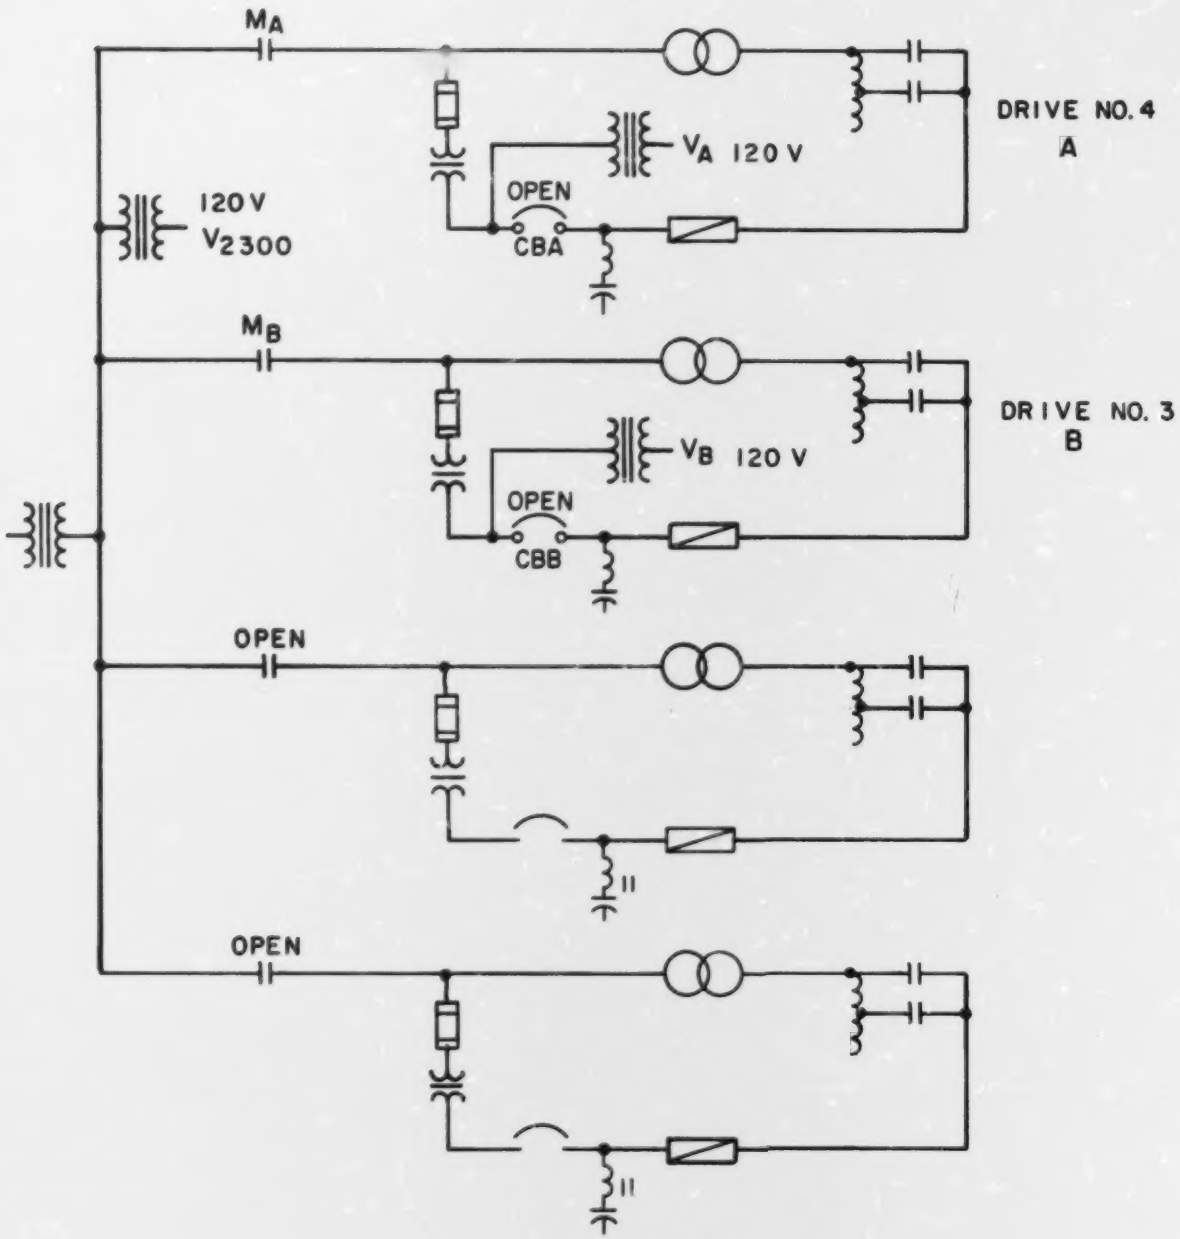
Figure C-3. – Test No. 2 system configuration.

NOTES: 1. GATES OFF AT ALL TIMES
2. CIRCUIT BREAKERS CBA AND CBB OPEN AT ALL TIMES
3. TEST NO. 2a - CLOSE M_A
4. TEST NO. 2b - CLOSE M_B WHILE M_A ALREADY CLOSED

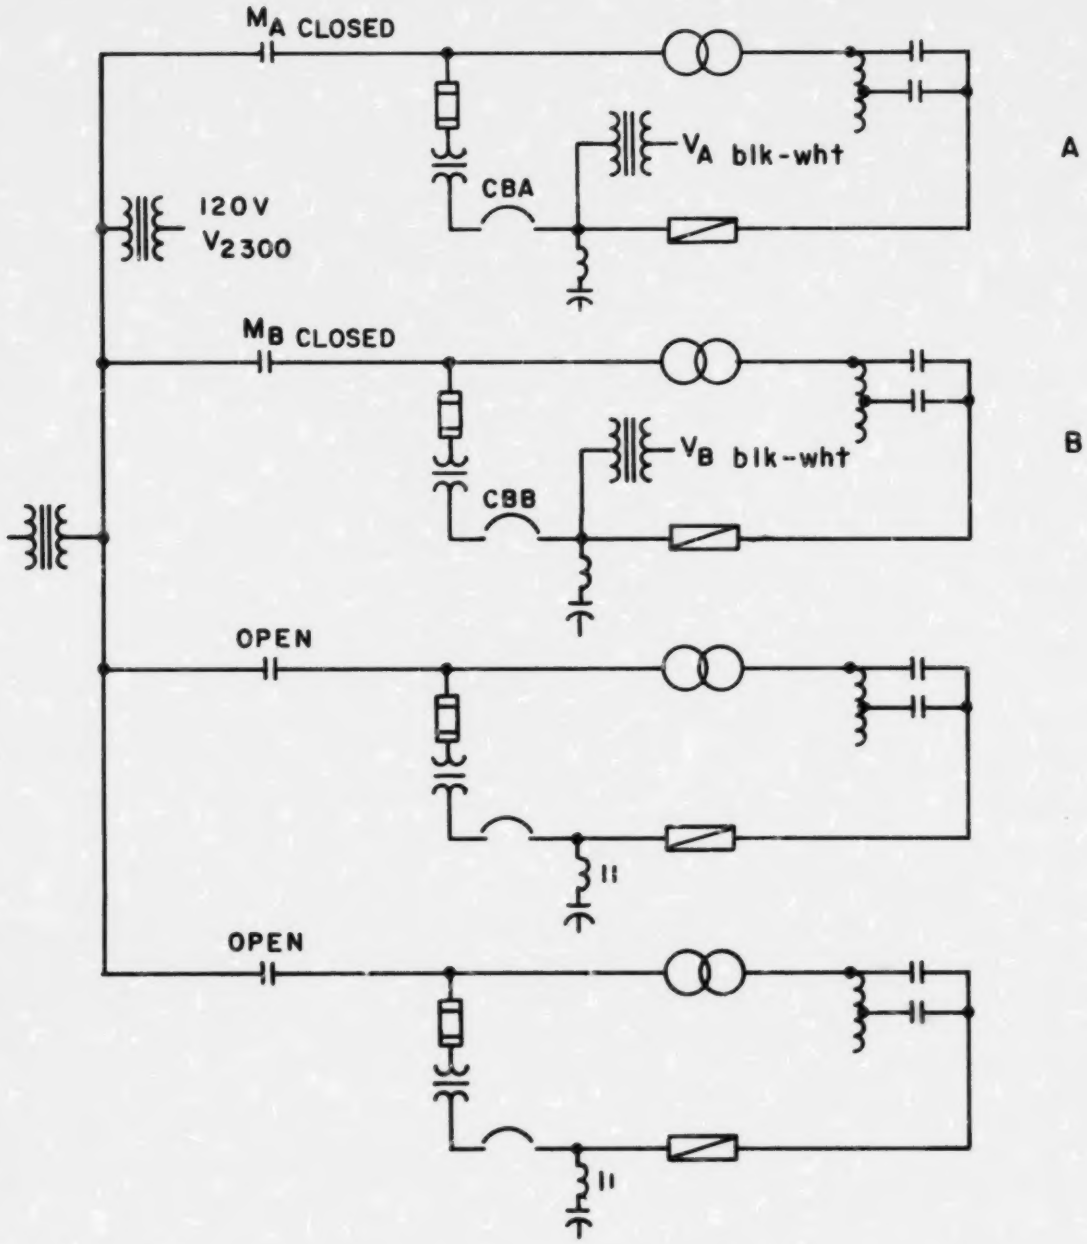
Figure C-5. – Test No. 3 system configuration.

NOTES: 1. GATES OFF AT ALL TIMES
2. SEPARATE PT 2300 : 120, M_A AND M_B CLOSED AT ALL TIMES
3. TEST NO. 3a - CLOSE CBA
4. TEST NO. 3b - CLOSE CBB WHILE CBA IS CLOSED

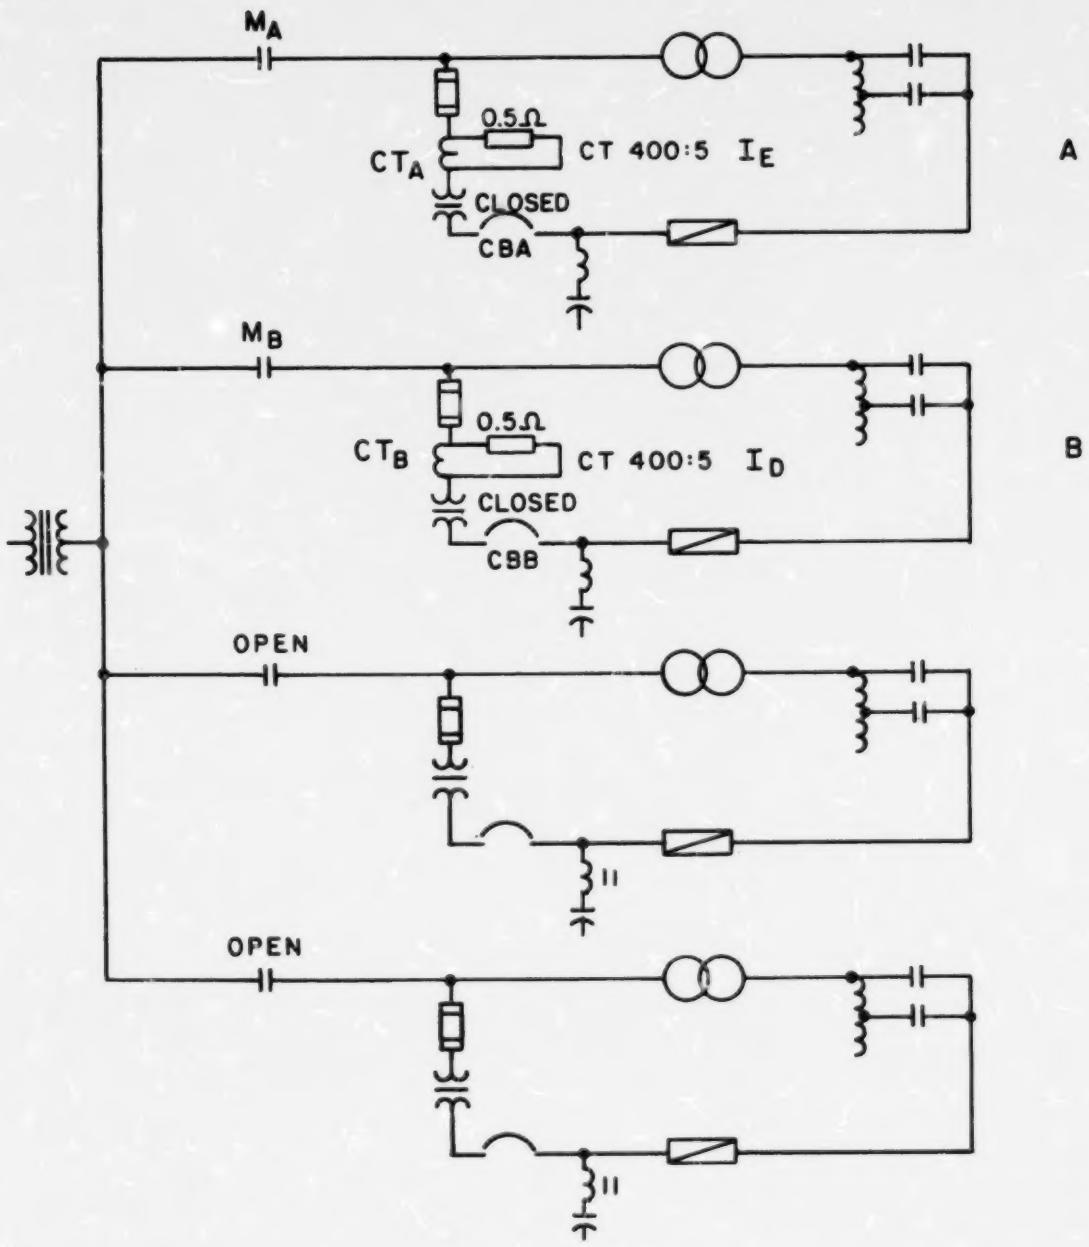
Figure C-7. – Test No. 4 system configuration.

From the results of test 4, switching the second filter network in draws more of the inrush current from the transformer on line than expected, causing disturbance within the on-line system.

NOTES: 1. I_E ACROSS CT_A, I_D ACROSS CT_B
2. CBA AND CBB CLOSED AT ALL TIMES
3. TEST NO. 4a - CLOSE M_A
4. TEST NO. 4b - CLOSE M_B WHILE M_A CLOSED

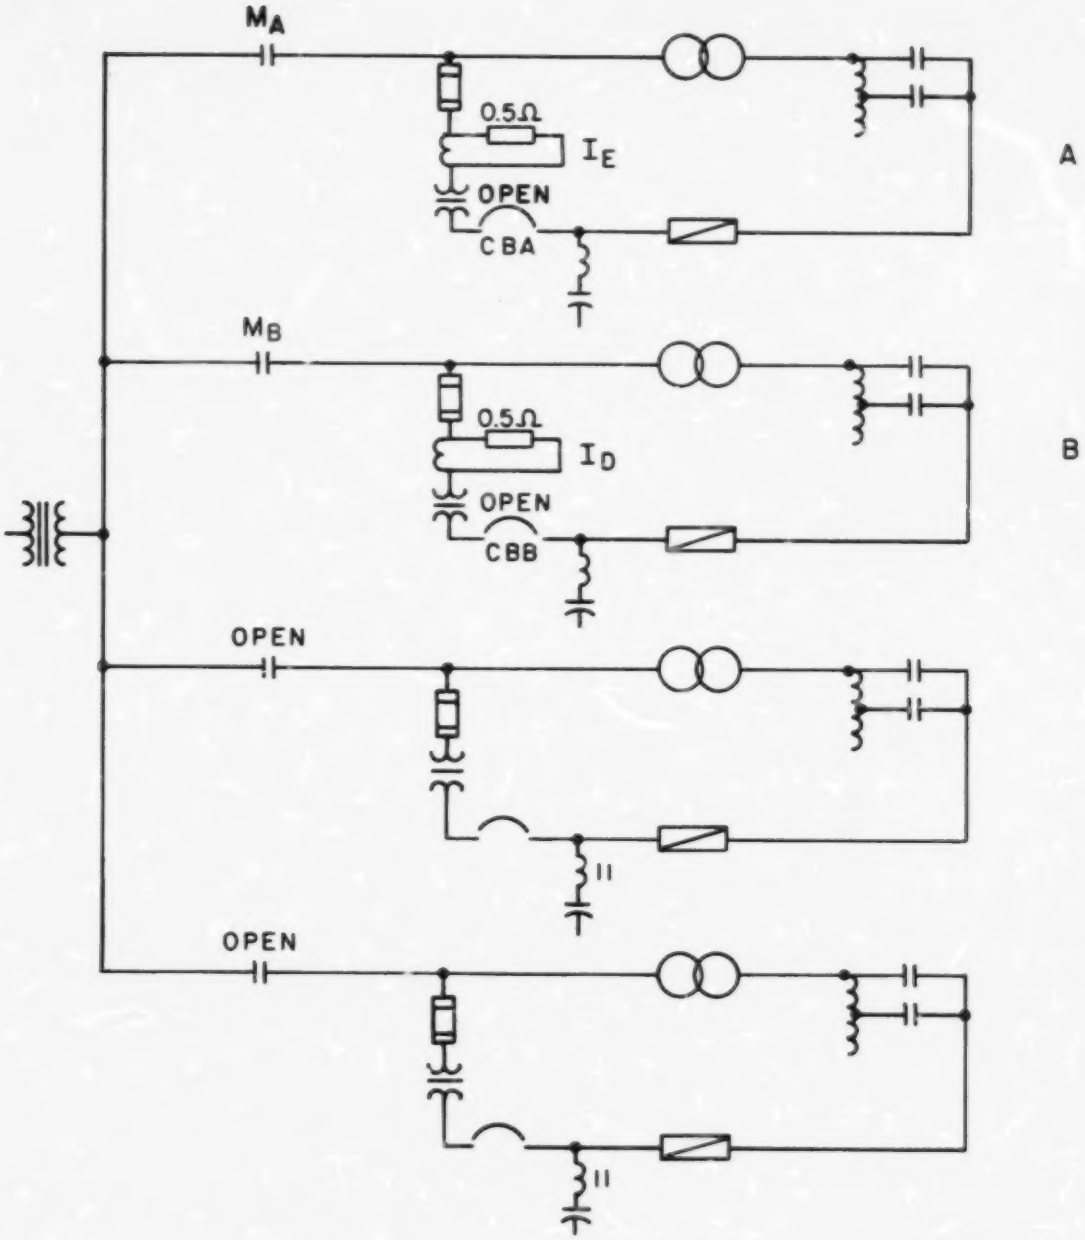
Figure C-9. – Test No. 5 system configuration.

NOTES: 1. CBA AND CBB ALWAYS OPEN AND GATES OFF
2. TEST NO. 5a – CLOSE M_A
3. TEST NO. 5b – CLOSE M_B AFTER M_A ALREADY CLOSED

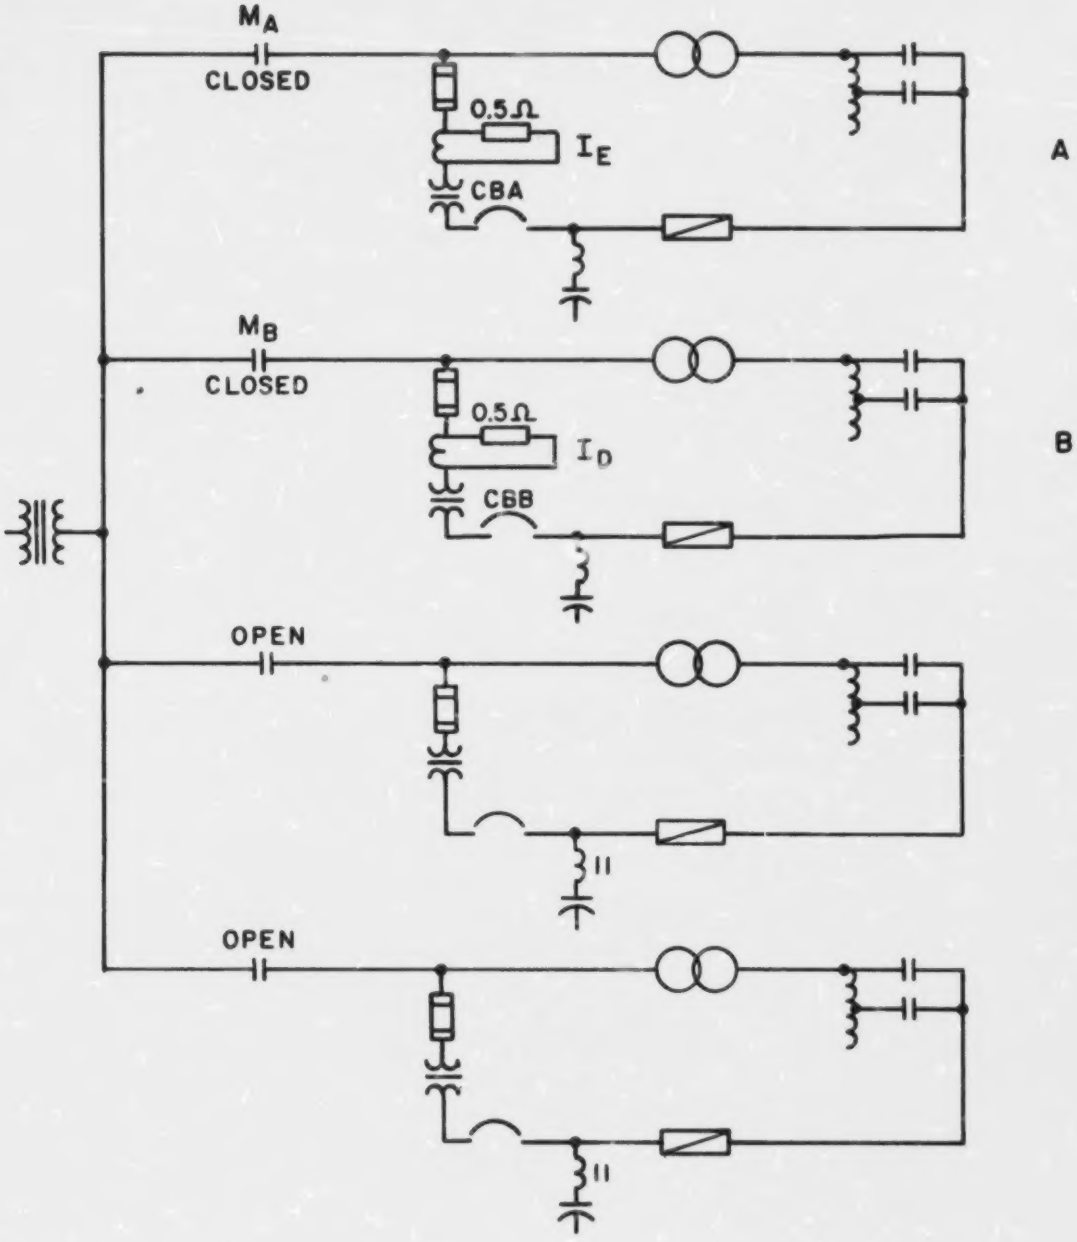
Figure C-11. – Test No. 6 system configuration.

NOTES: 1. GATES OFF AT ALL TIMES
2. M_A AND M_B CLOSED
3. TEST NO. 6a – CLOSE CBA
4. TEST NO. 6b – CLOSE CBB WHILE CBA ALREADY CLOSED

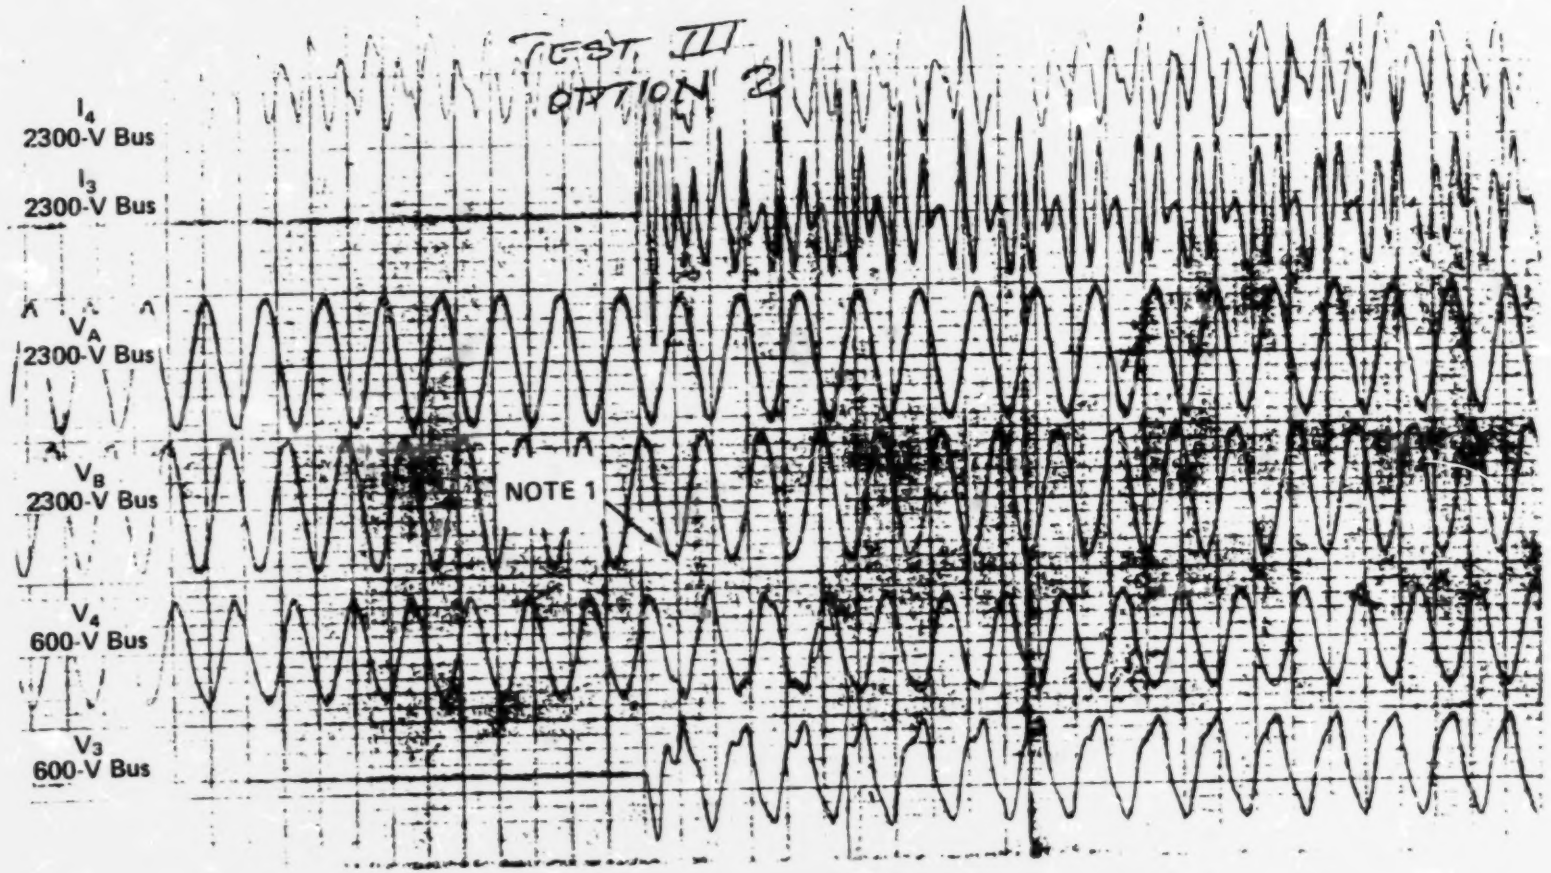
NOTE 1: Note the distortion in the negative peaks only, and the relationship to the I_3 positive peaks.

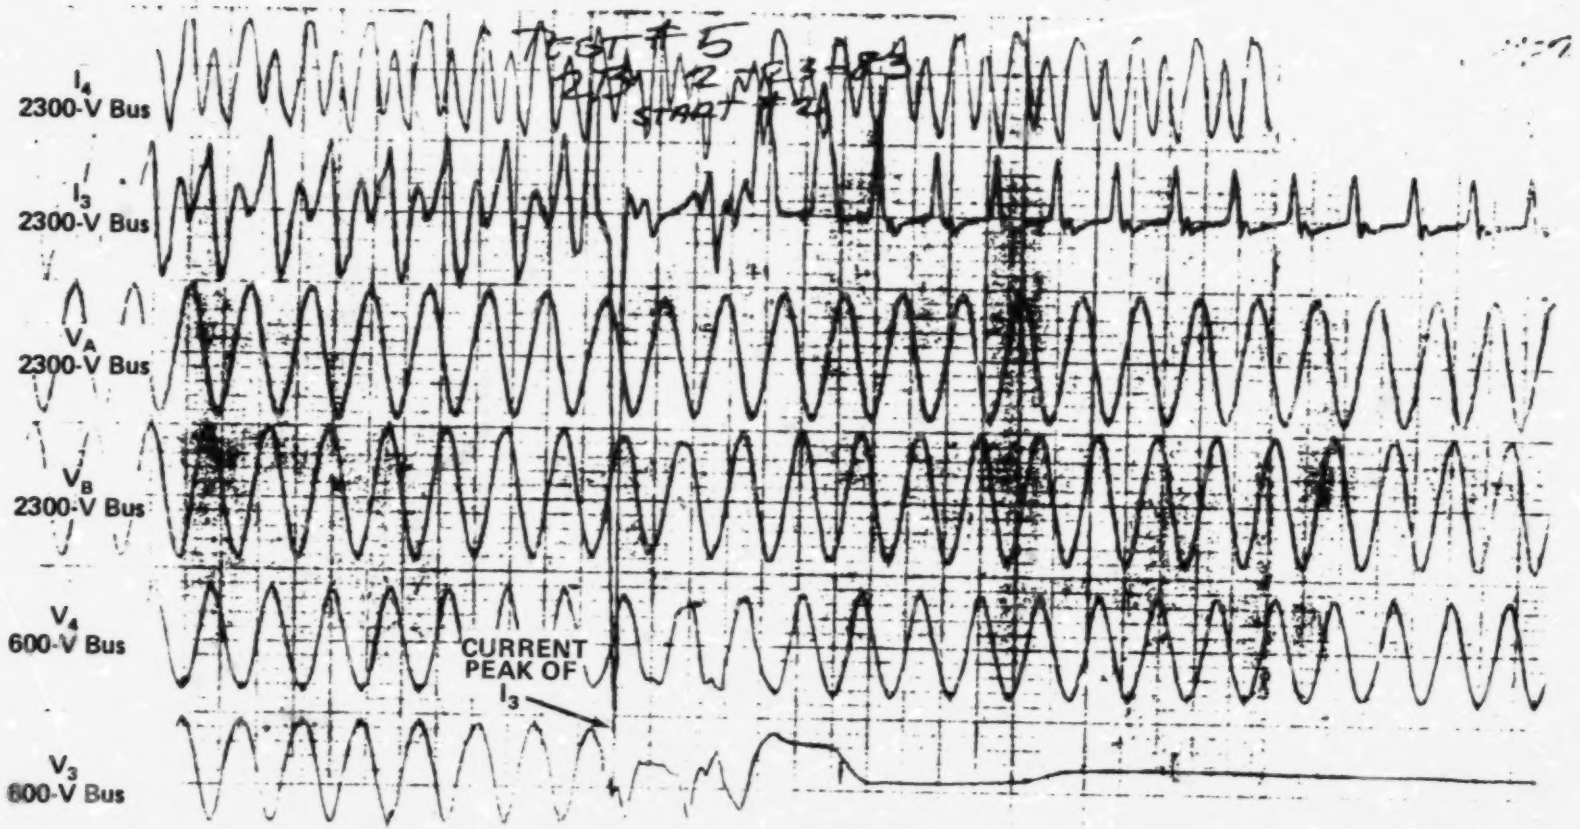
Figure D-2. – Test 5-2B oscillogram.

weak system. Being specific, with respect to test 5-2B, the report states, ". . . this failure was due to a severe voltage drop on the 2300-V line in the order of magnitude of 10 percent or greater." We disagree with this statement and believe the data presented in the consultant's report indicate the severe voltage drop was due to an inverter silicon-controlled rectifier misoperation that applied a phase-to-phase fault on the 600-V bus, thereby reducing the system voltage.

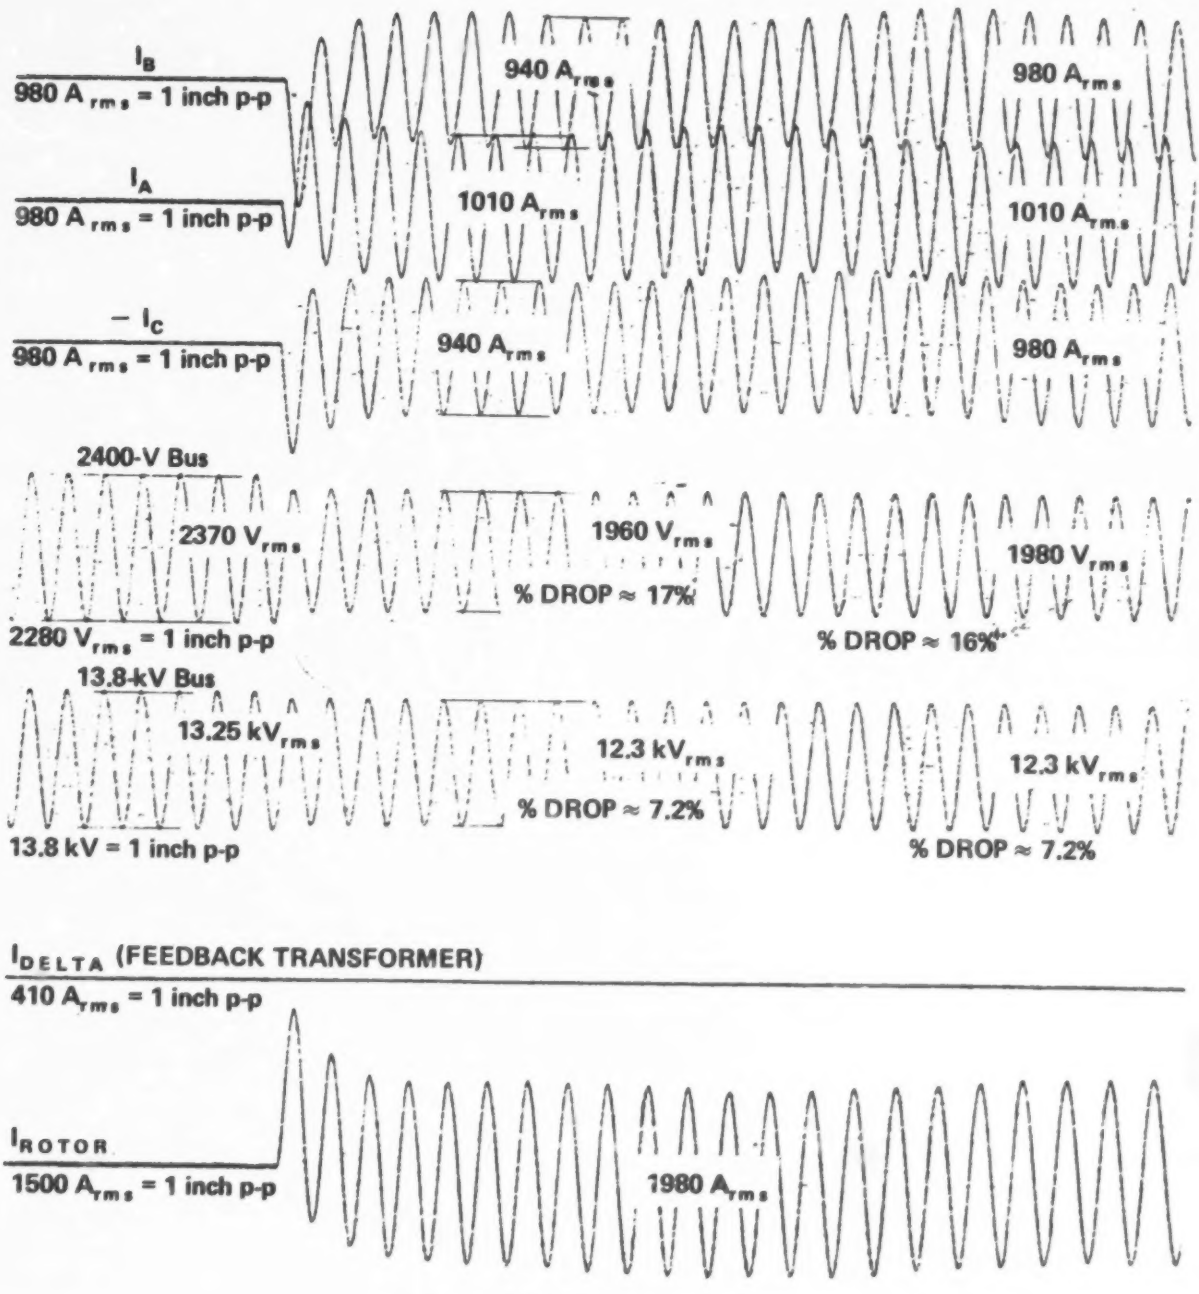
Figure F-2. – Induction motor start oscillogram.

Test No.	Description	Data
3	When starting unit 4, unit 3 tripped off-line	Voltage drop = 1.6%
	When starting unit 2, unit 4 tripped off-line	Voltage drop = 1.2%
5C	When starting unit 3, unit 4 tripped off-line	Voltage drop = 1.2%
		Average voltage drop ≈ 1.3%

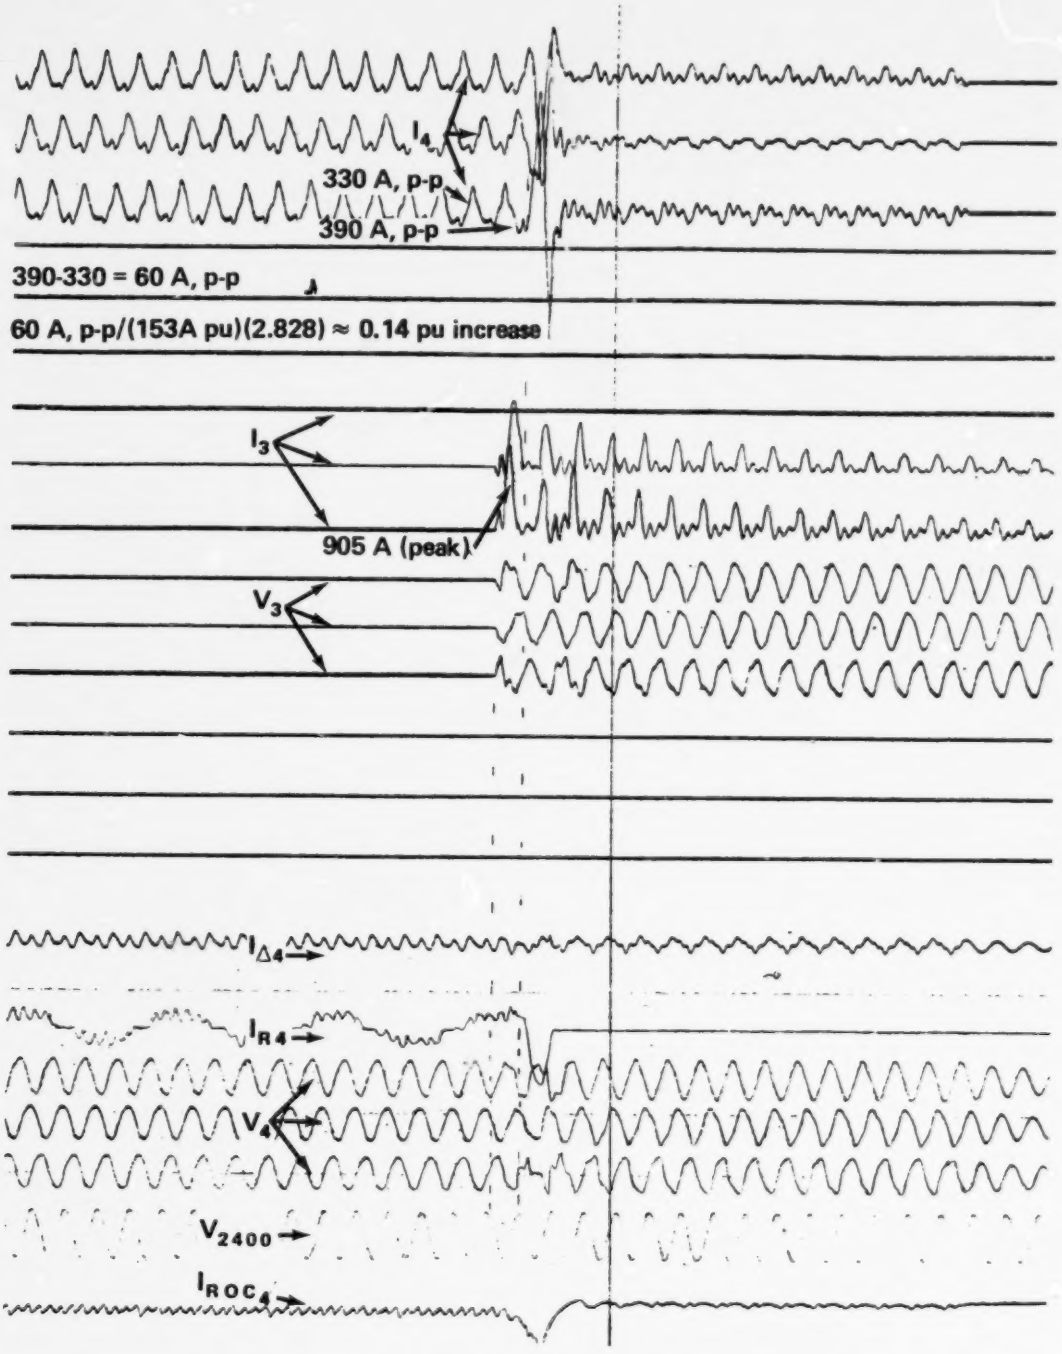
Figure G-1. – Test 4B oscillogram.

It appears that the voltage induced across the feedback transformer is related to the higher frequency components of the inrush current. The harmonic like current in the feedback transformer circuit of a running drive (be it either inrush current related or filter oscillation related) induces a voltage across the transformer and, when superimposed with the 60-Hz system voltage waveform, results in the sum of the two signals appearing on the 540-V inverter side of the transformer. The composite signal is a distorted waveform which produces errors in the gate firing circuits thereby producing phase-to-phase faults in the converter package that trips the equipment off-line. The ability of the drives to ride through this period is dependent on the percent distortion factor of the 540-V bus. Furthermore, the percent distortion factor is a plant design parameter that must be considered in the selection of all associated equipment. To produce a workable system, the equipment must be sized properly to keep the percent distortion factor below the critical limit, above which the equipment will no longer operate properly. In summary, during the initial stages of equipment design, some thought should have been given to equipment integration and the resultant percent distortion factor to ensure proper plant operation. For a detailed analysis of this problem, please refer to appendix F of this report.

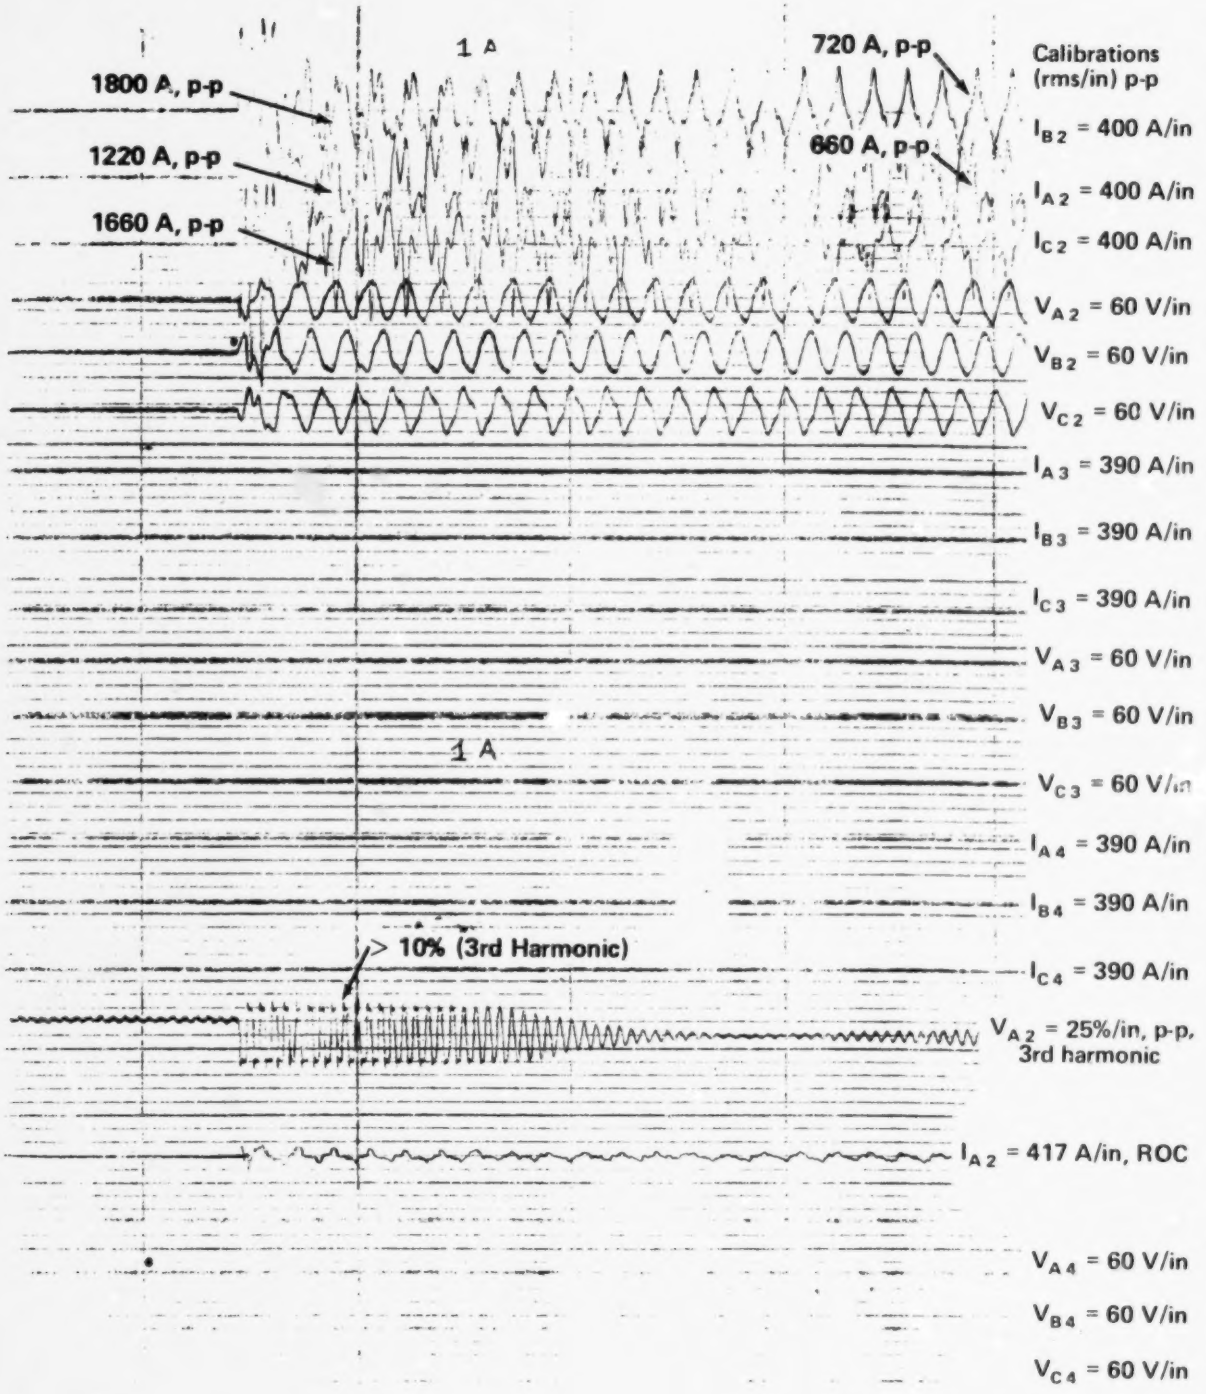
Figure H-1. – Test 1A oscillogram.

The test investigation again indicates that the system capacity is indeed sufficient. The startup problems revolved around the high feedback transformer impedance, which severely limits the drive SCR to the point that the drives will not function properly. The insertion resistor scheme eliminates the startup problem by reducing the SCR requirements of the drive.

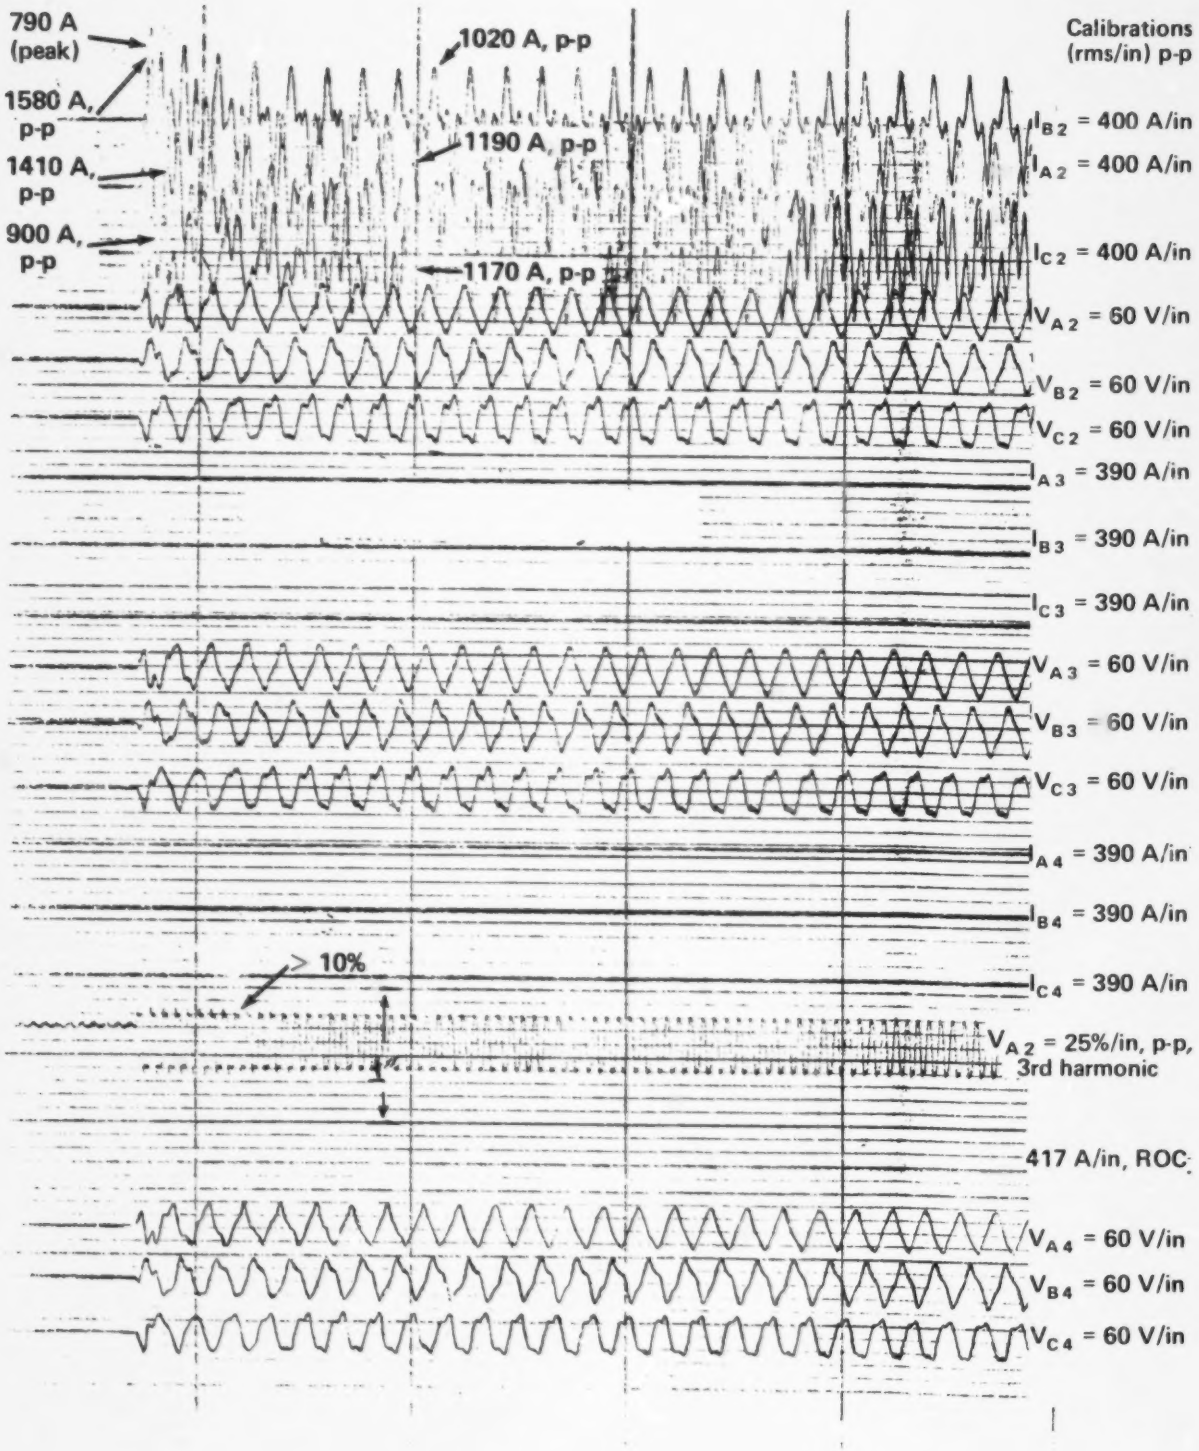
Figure H-6. – Test 5B oscillogram.

Tests 5, 6, and 8 consisted of energizing and deenergizing the unit with the special insertion resistor and contactor while the other two units were on-line. In all, 20 successful attempts were obtained without a single failure. There was a problem with control circuit fuses blowing, but this was traced to the unrelated failure of an under/over voltage protection relay, which was removed from the circuit and testing resumed. Test 7 was similar to tests 5, 6, and 8 except that the rotor circuit on the unit with the insertion resistor (unit 4) was now enabled, thereby allowing a complete start sequence while the other two units were running.

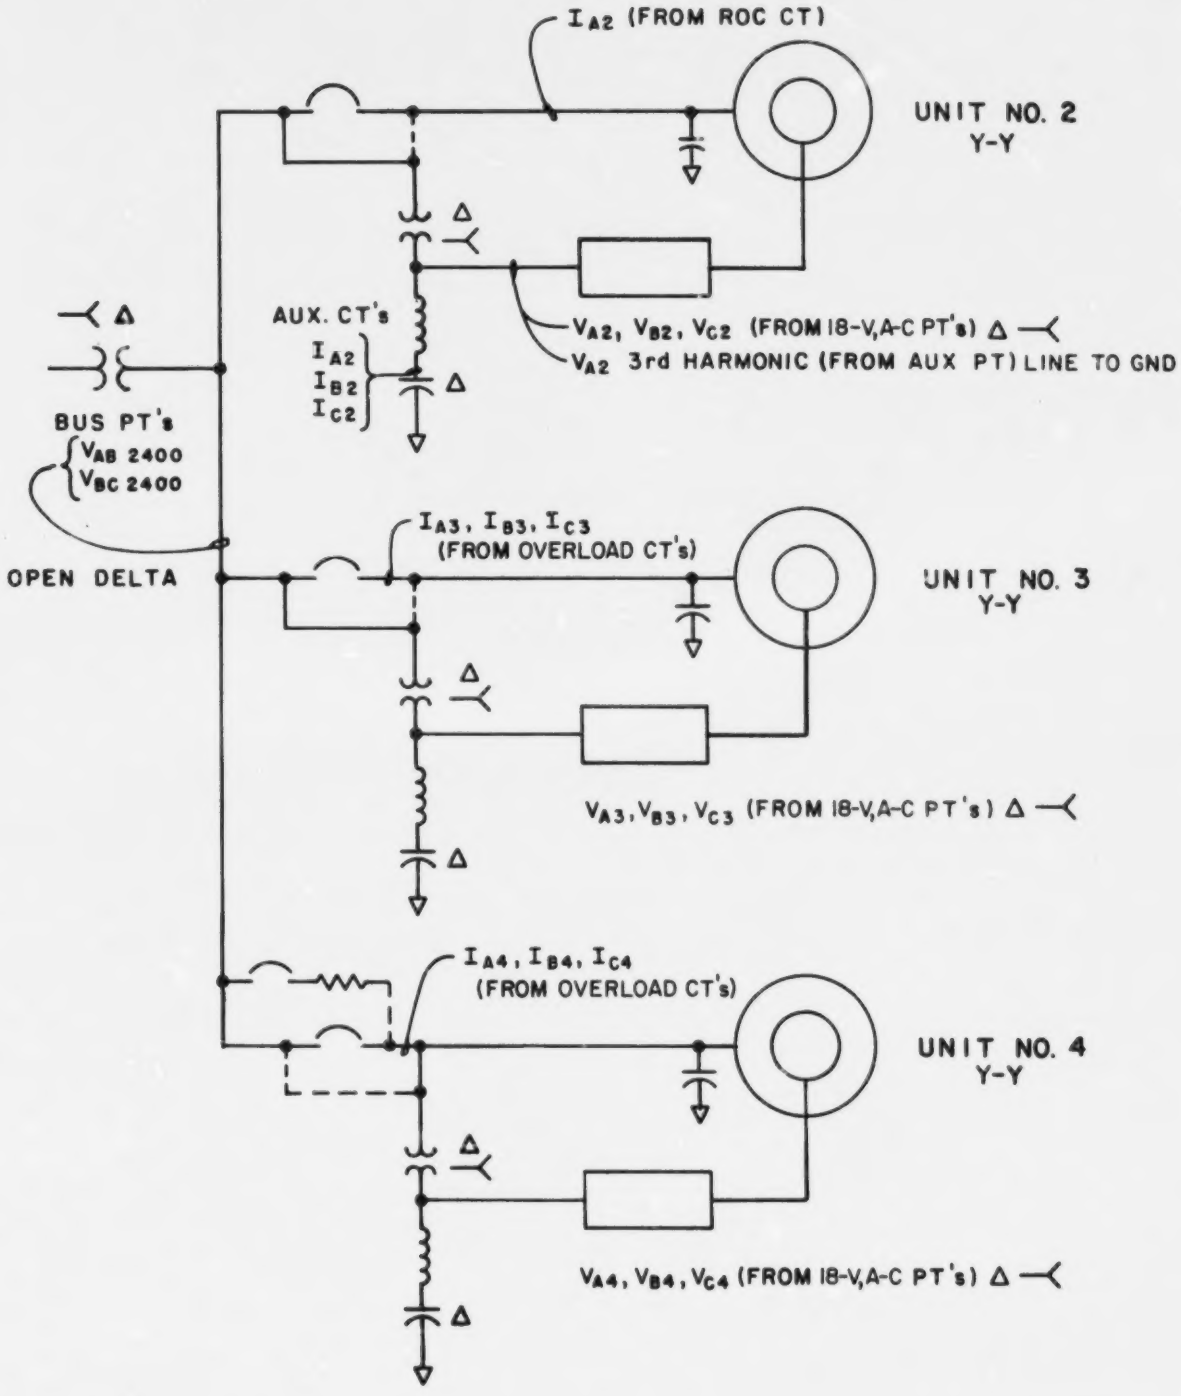
Figure H-8. – Test 9B oscillogram.

In support of the previous analysis, the filter current waveforms were duplicated on paper from only the fundamental and 3.3 component. In the graphical construction, the 3.3 cosine component was assumed to be synchronized to the B-phase cosine fundamental. This assumption was necessary to obtain a B-phase triangular waveform. The three composite waveforms were generated by adding the fundamental to 11 percent of the 3.3 frequency component. This produced fairly accurate reproductions of the B- and C-phase waveforms but failed to produce the correct A-phase waveform. However, a nodal analysis of the circuit indicated that to preserve current balance, the A-phase waveform should be composed of the fundamental minus two times 11 percent of the 3.3 component. This resulted in a very good reproduction of the A-phase current waveform. The reproductions are shown at the top of figure H-13. The actual oscillograph current trace waveforms obtained during test 9B (fig. H-8) are shown at the bottom of figure H-13.

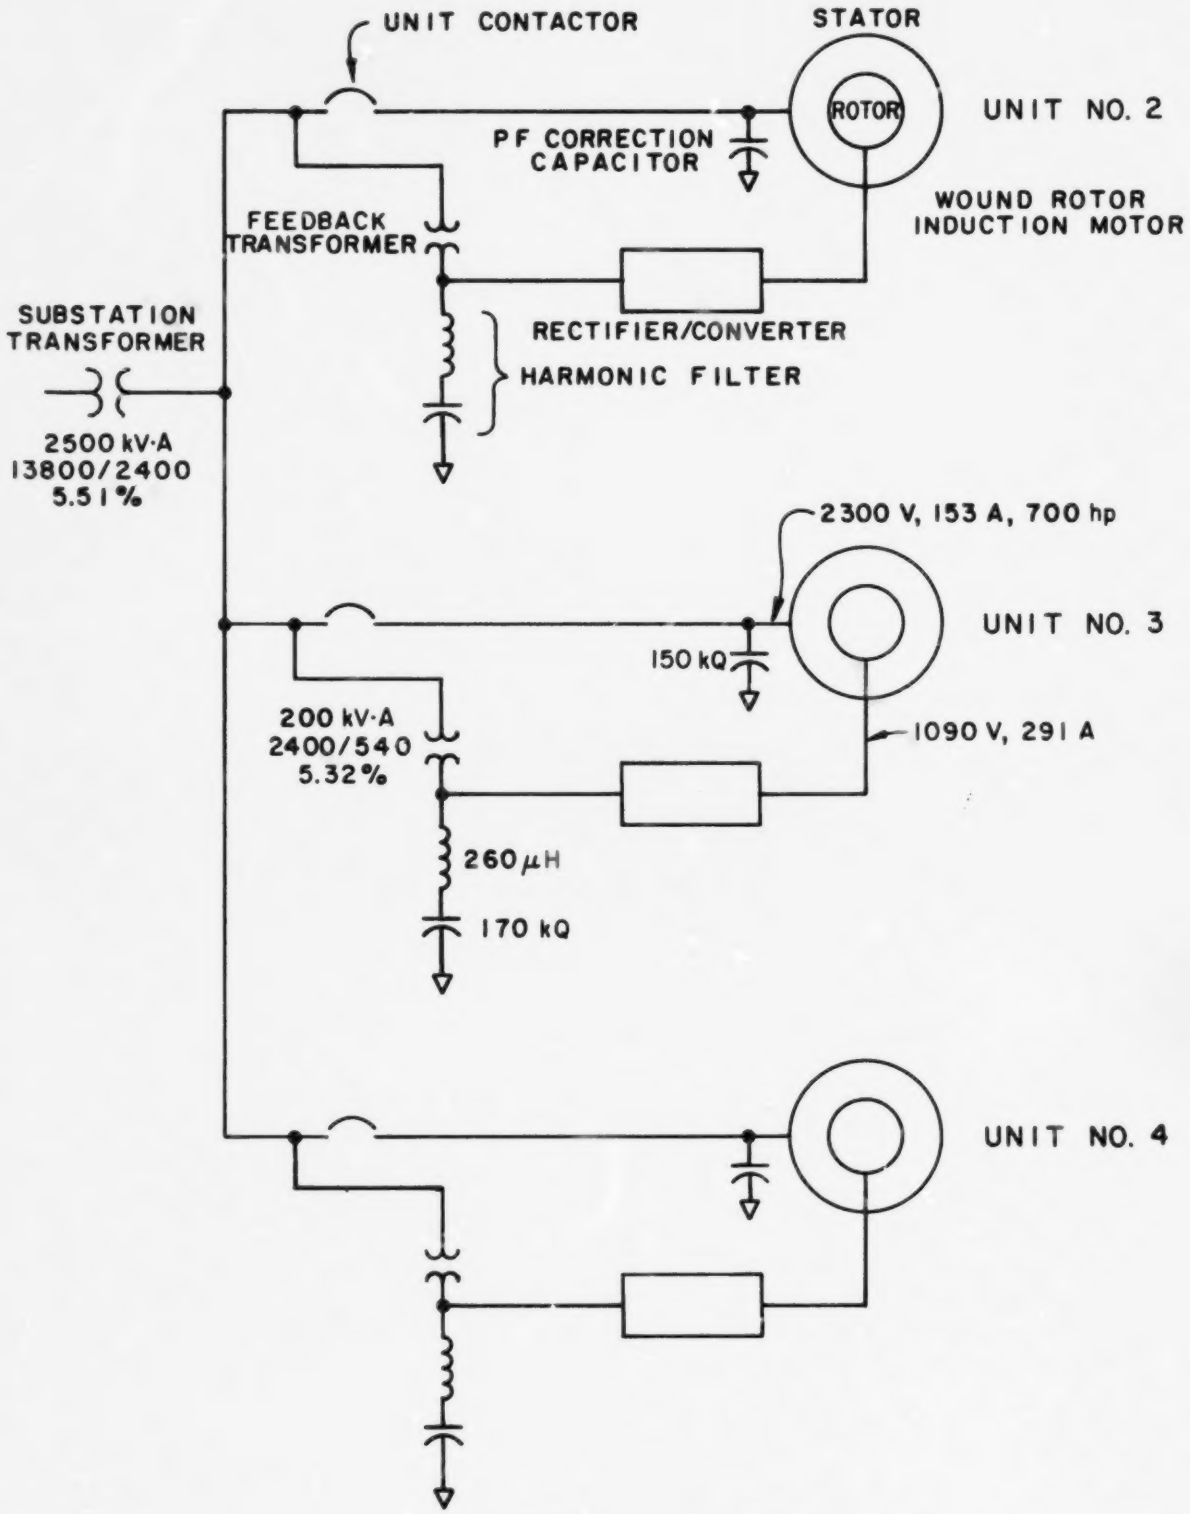
Figure H-11. – Alternate feedback transformer configuration.

The capacitor modifications separately, and in conjunction with rewiring the feedback transformers to the line side of the unit contactors, were not successful in eliminating the startup problem. However, the insertion resistor scheme was most successful in eliminating the problem. There were 22 successful startups out of 22 attempts. Based on this success record, it was recommended that each of the Fountain Valley units be modified for insertion resistor starting.
